**PHASE I  
ENVIRONMENTAL SITE ASSESSMENT**

**405 & 413 S. PARK STREET, 845 VILAS AVENUE  
MADISON, WISCONSIN 53715**

**PREPARED FOR:  
MCFARLAND STATE BANK**

**DATE OF REPORT:** November 14, 2005

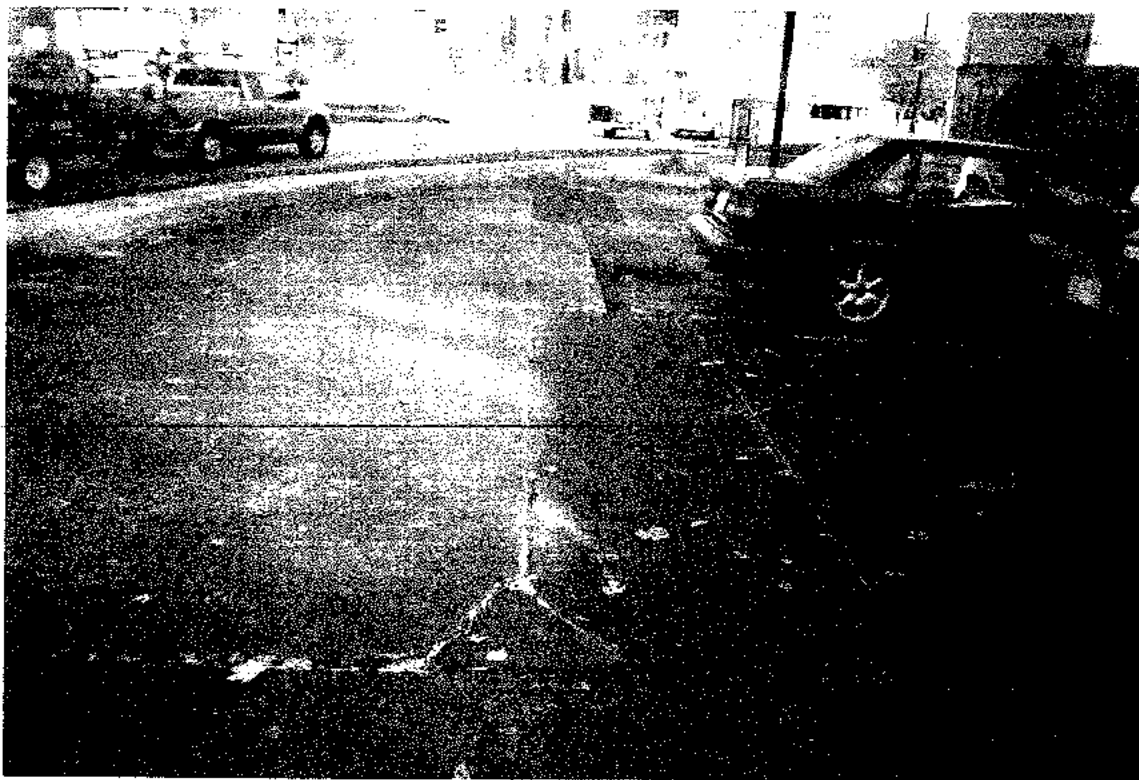
b) It appears that the property at 405 S. Park Street had been used as a gasoline station for over 30 years. There is evidence that USTs were located on the north and east sides of the parcel, and that there were gasoline pump islands on the north end of the parcel. At a minimum there have been four 2,000 gallon gasoline USTs on the property. There are no records showing that the tanks have been removed. Therefore, soil and groundwater samples should be collected in the area of the former pump islands and the former locations of the USTs. The samples should be laboratory analyzed for gasoline range organics (GRO) and petroleum volatile compounds (PVOC) plus naphthalene. At least one soil and one groundwater sample should be analyzed for diesel range organics (DRO) and polycyclic aromatic hydrocarbons (PAH).

8. VIEW OF THE CONCRETE PATCHES IN THE PARKING LOT AT 405 S. PARK STREET. THESE PATCHES APPEAR TO BE THE FORMER LOCATION OF GASOLINE STATION PUMP ISLANDS.
